AIRPLANE LANDING MAT INVESTIGATION TESTS ON STEEL, PIERCED TYPE, M7

TECHNICAL MEMORANDUM NO. 3-266

WATERWAYS EXPERIMENT STATION
VICKSBURG, MISSISSIPPI

DECEMBER 1948

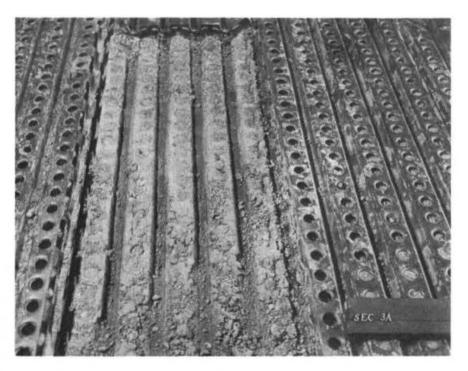
Fig. 2. Appearance of subgrade after removal of plank at 528 coverages

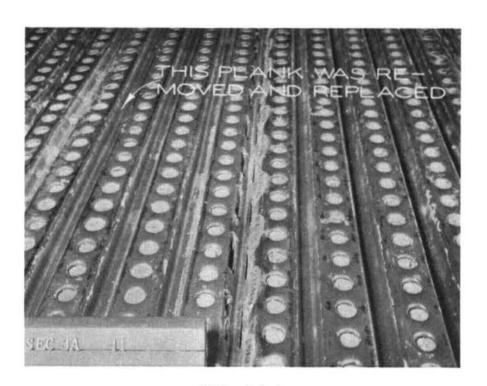
Side joint

End Joint

Welded joints where plank was replaced in area of M7 landing mat

men replaced the plank in 20 minutes. The closing side joint was made by welding each bayonet of the plank being replaced to the adjacent planks. The end joint where all bayonets had been cut away was also welded. The welding time was 30 minutes. These welded joints held satisfactorily throughout the remainder of the test. Plate 9 shows the metal cut away in order to remove the plank and the appearance of the subgrade after the plank was removed. Plate 10 shows the welded joints.

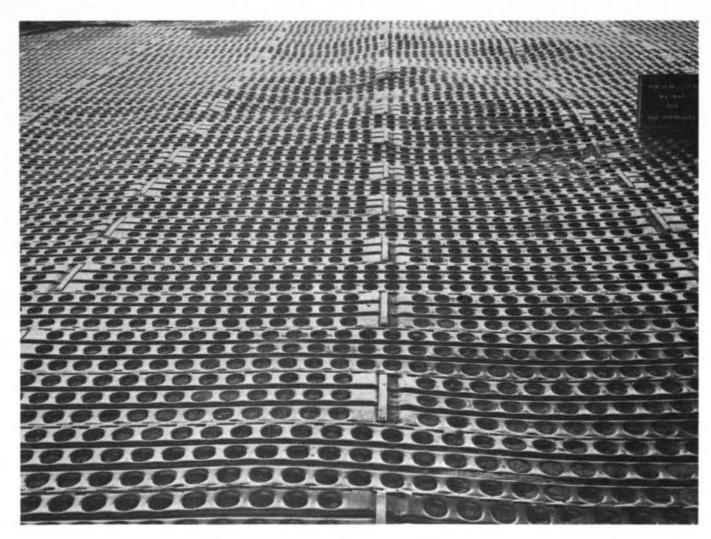
M6 mat in section 4 after 966 coverages

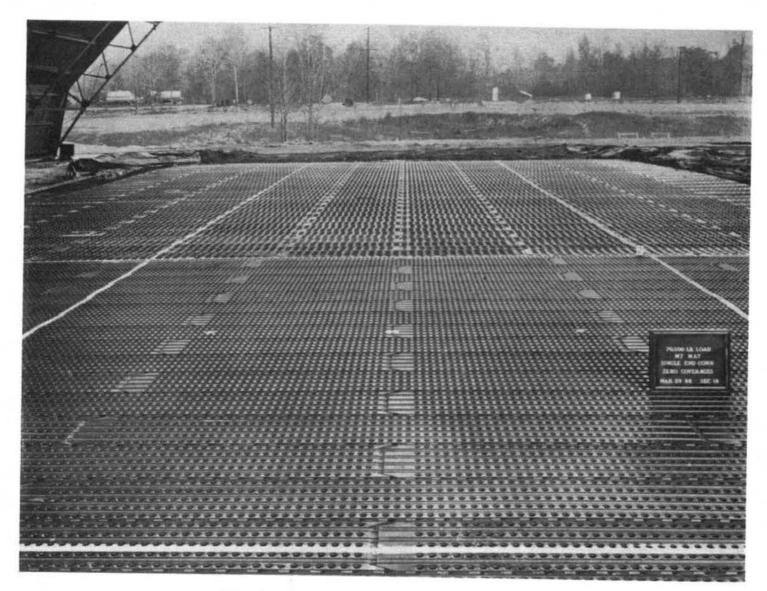
M7 and M6 mats in lane 1 before testing

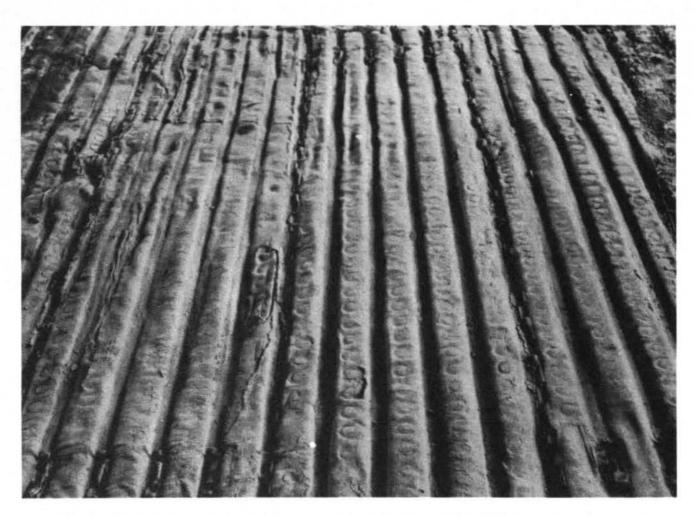
Appearance of PBS after removal of M7 mat at 1000 coverages

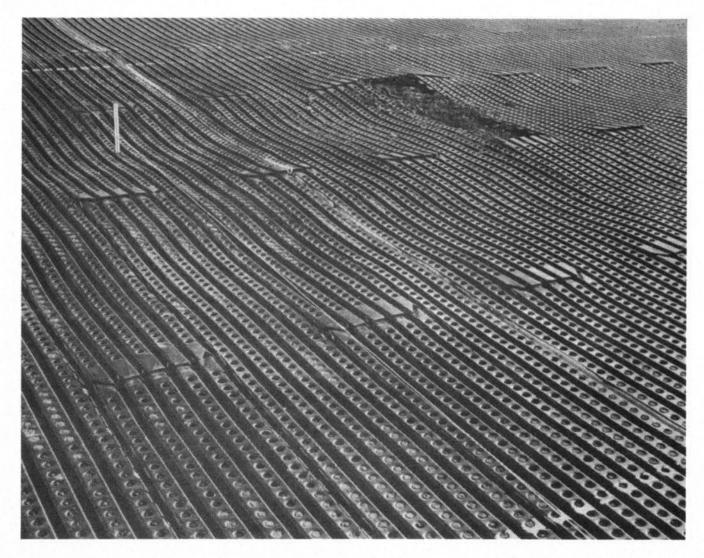
Appearance of M7 mat surface, subsection 5b after 182 coverages (the half plank was removed to permit soil sampling)

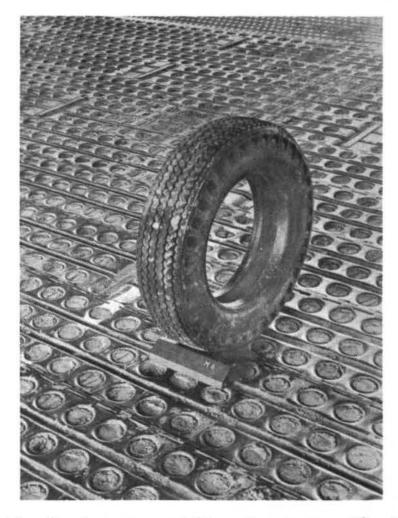
Fig. 2. Appearance of tire after test on M6 mat

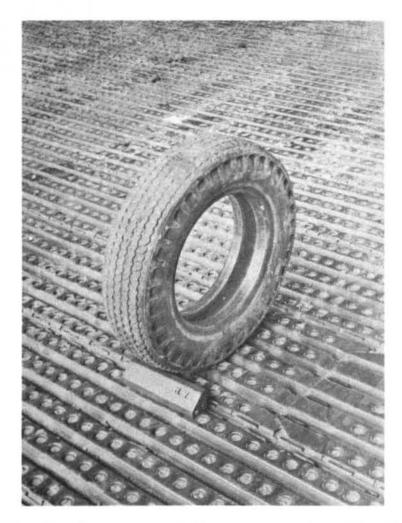
Fig. 1. Appearance of tire after test on M7 mat
